Sunnyview Pre-Construction Monitoring Report

Prepared for:
The Harford County
Department of Public
Works

December 2006
Revised April 2007

Prepared by:
KCI Technologies Inc.
10 North Park Drive
Hunt Valley, MD
21030

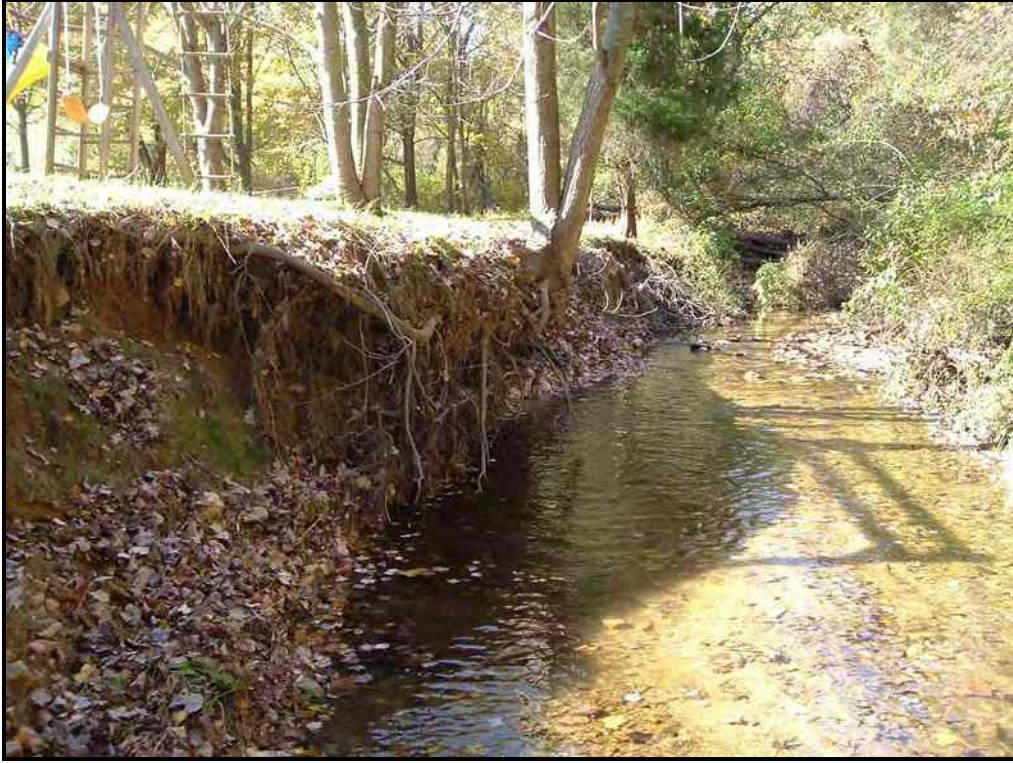
Photo 7 Facing up stream of blockage at station 2+35

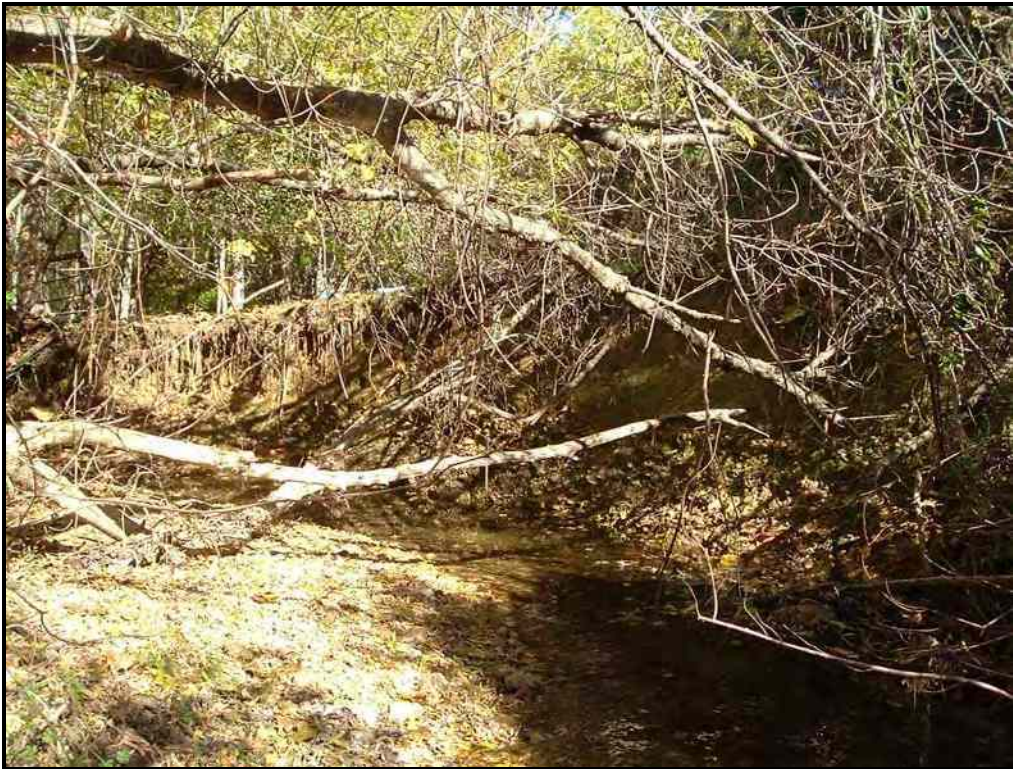
Photo 8 Facing up stream at station 3+43 at blockage

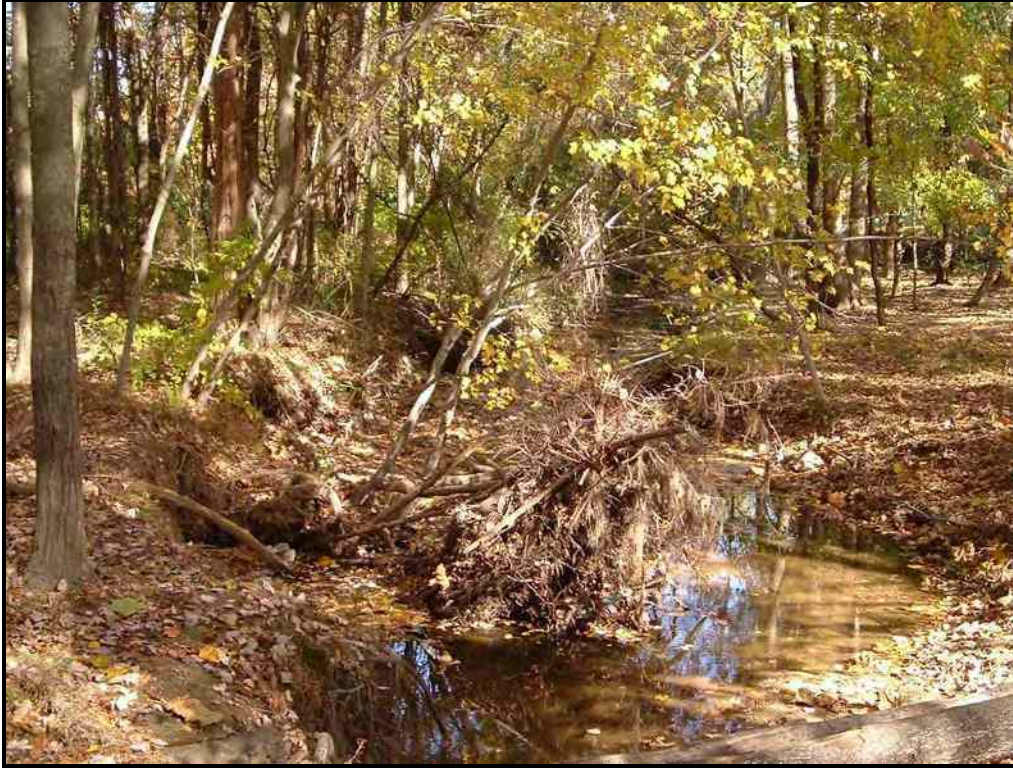
Photo 11 Facing up stream of blockage at station 5+46

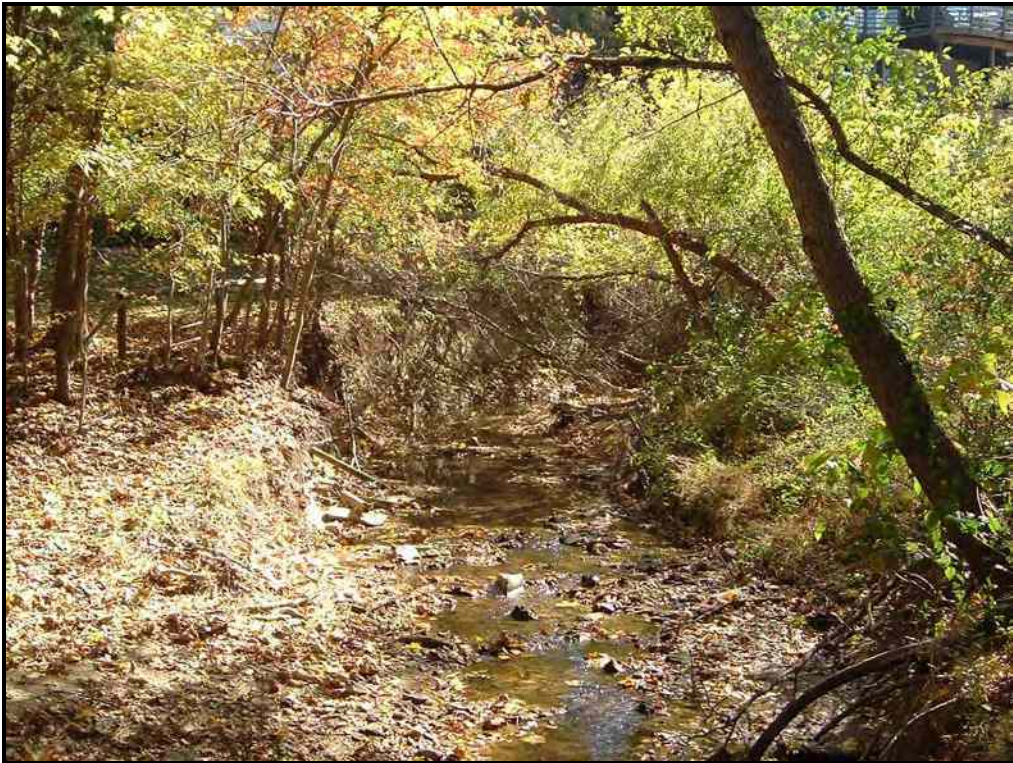
Photo 12 Facing down stream of blockage at station 5+46

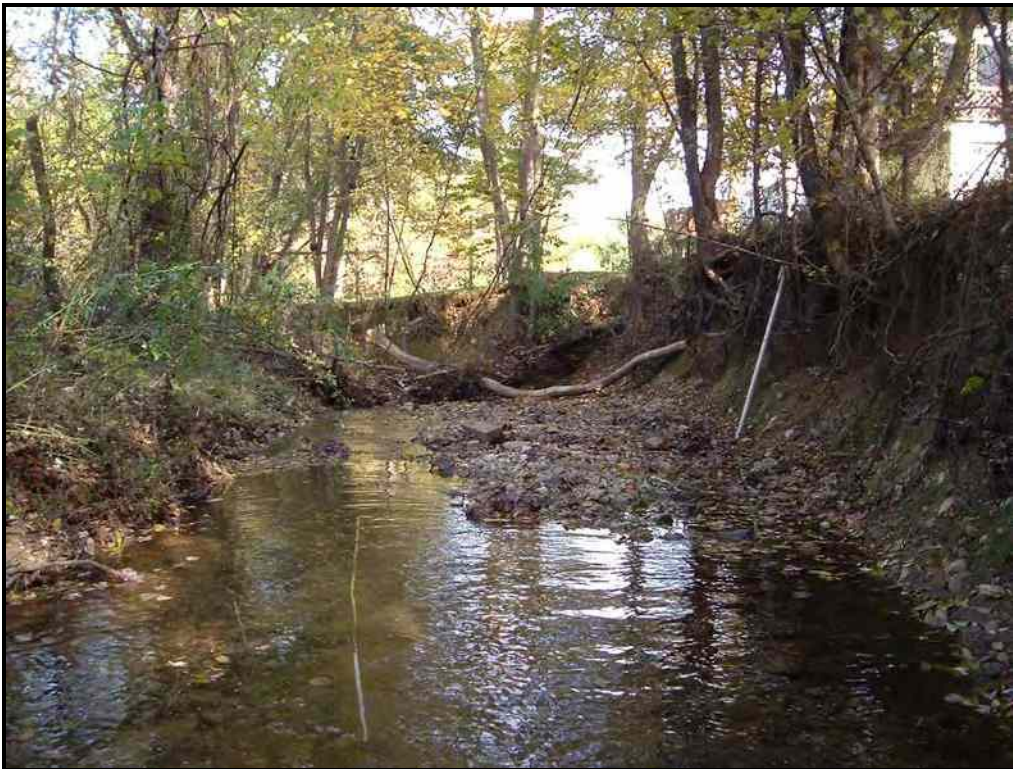
Photo 16 Facing down stream at cross section 2 looking at blockage at station 8+08

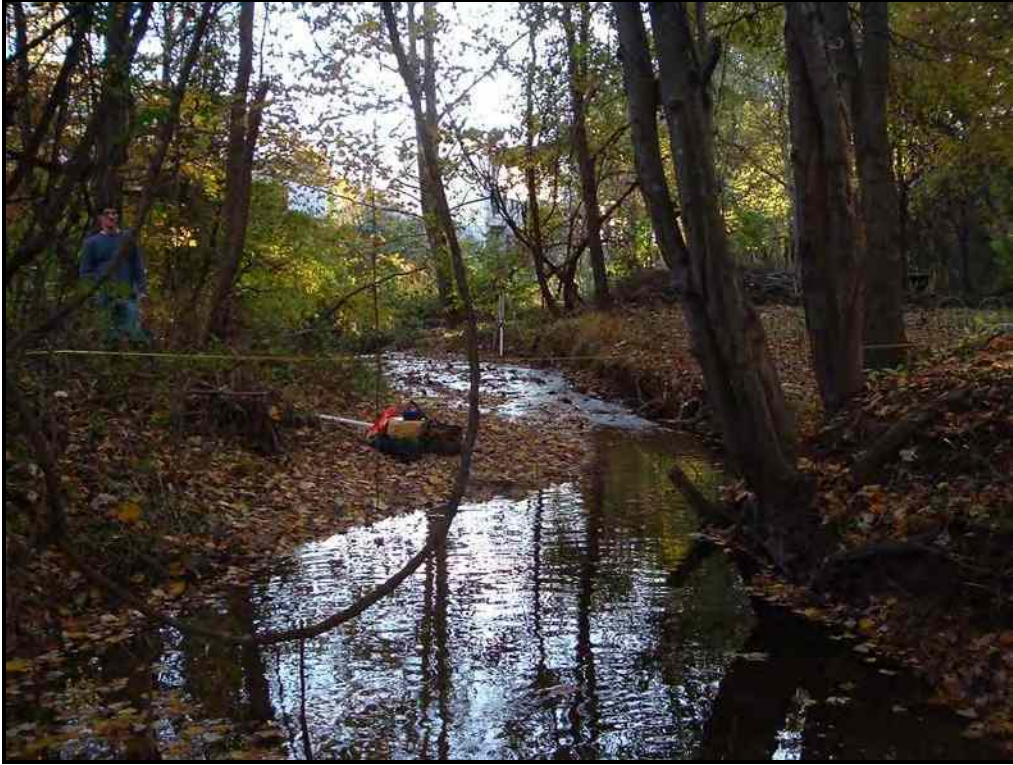
During the baseline condition monitoring, bed and bank pins were installed and the exposed length of each pin was measured. At Station 12+70, the bank is eroding around an exposed tree root, which prohibited installation of more than one bank pin. Scour chains were not installed at the site. In lieu of scour chains, the channel pin will be monitored for total bed erosion or deposition.

Photo 21 Facing up stream at station 12+70 (cross section 4)
